Recovery from tank incident

ERA

ERA's Ranger mine had a leach tank failure within the processing area on Saturday 7 December 2013. Ranger's processing operations have been shut down and the clean-up is well-advanced.

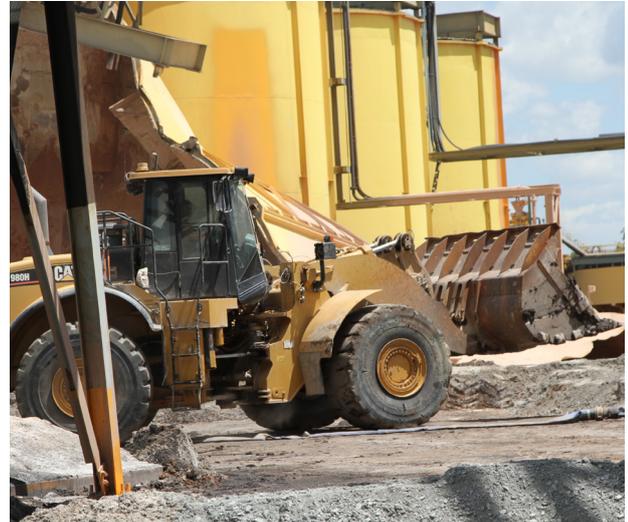
This image shows a loader assisting to clean up the material in front of the failed leach tank

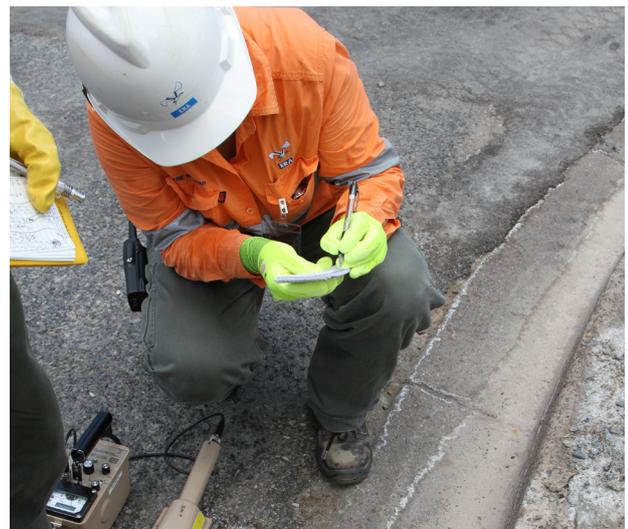
A Radiation Safety Advisor checks that the radiation dose levels of the material is well within safe levels
