# Recovery from tank incident

## Update #3

**ERA**

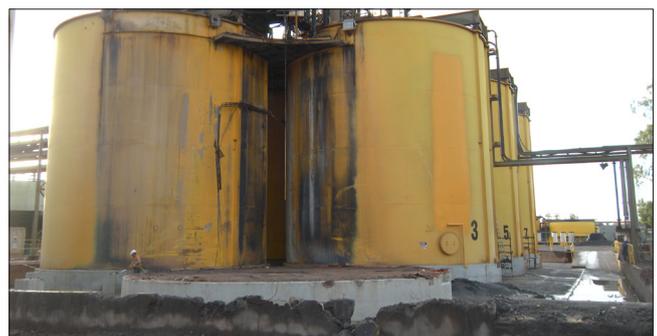
The base of Leach Tank 1 following the removal of the tank and other infrastructure.
