Recovery from tank incident

ERA

Ranger mine is recovering from a failure of Leach Tank 1 that occurred on Saturday 7 December 2013. Ranger's processing operations have been shut down and the clean-up is well-advanced.

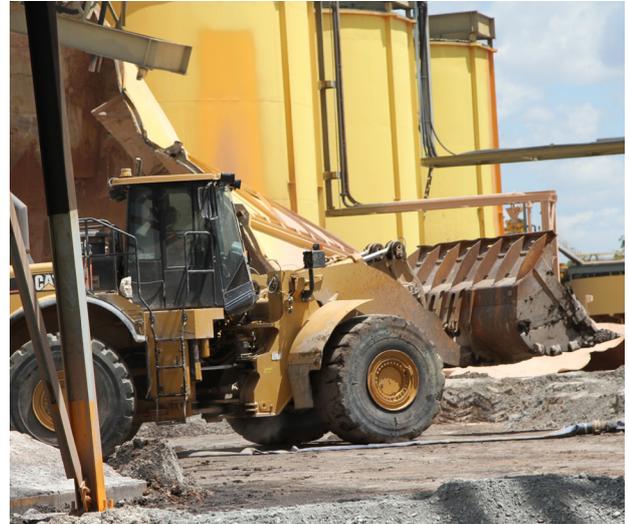
This image shows a loader assisting to clean up material in front of the failed leach tank

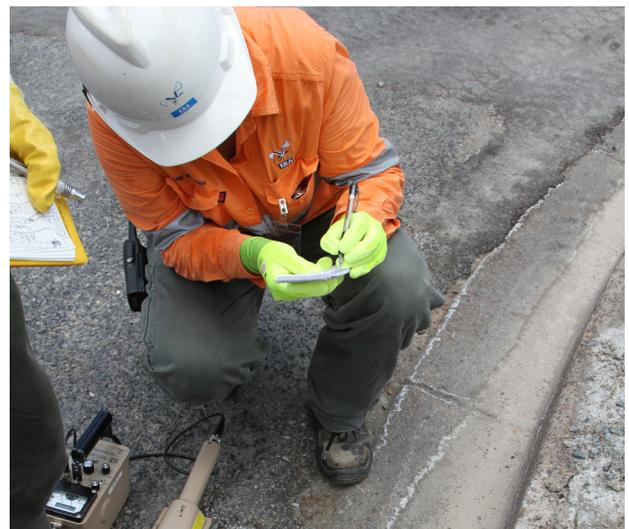
A Radiation Safety Advisor checks that the radiation dose levels of the material is well within safe levels
